WONDER QUEST with April Holladay, A Weekly Column \* February 7, 2001\* Albuquerque

## Crackling power lines

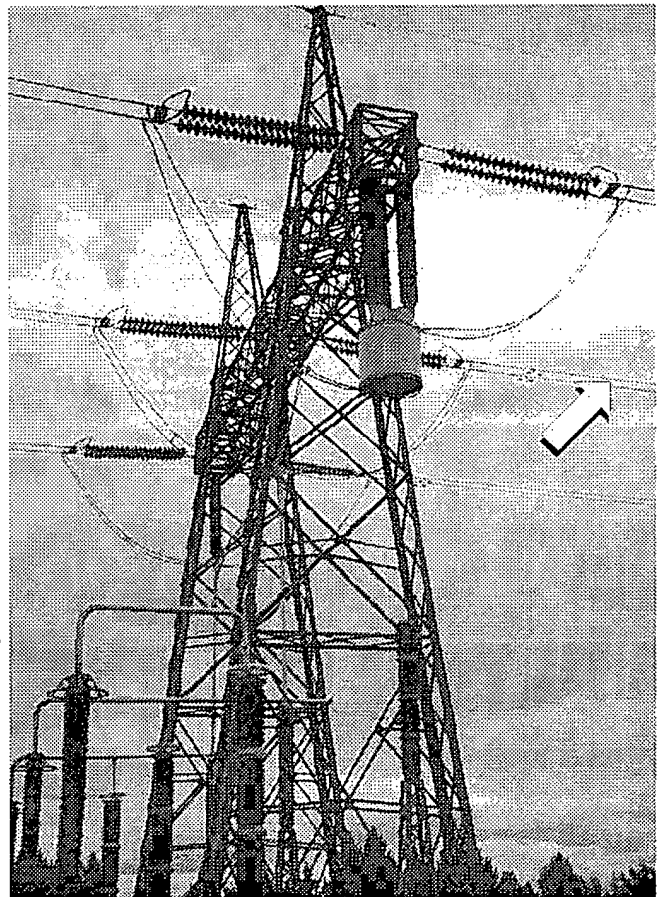
**Figure Caption:** [Public Service Company of NM] Electrical transmission towers and high-voltage (345,000-volt) power lines near Albuquerque, New Mexico. The arrow points to the energized wires, which are likely places for corona discharge to occur.

High-voltage power lines carry 230,000 volts or more, which is enough, to cause an electrical discharge from the conductors under certain conditions.

"The presence of moisture in the air or on the conductor promotes electrical conduction and reduces the voltage required for corona onset to occur," says Richard Johnson, an electrical engineer at the Public Service Company of New Mexico. There is always a small amount of corona discharge going on, he says. "The presence of moisture simply magnifies the effect."
